Addendum 1

Overbrook Avenue NW Storm Sewer Rehabilitation Project, GP 1217

Inspection Report

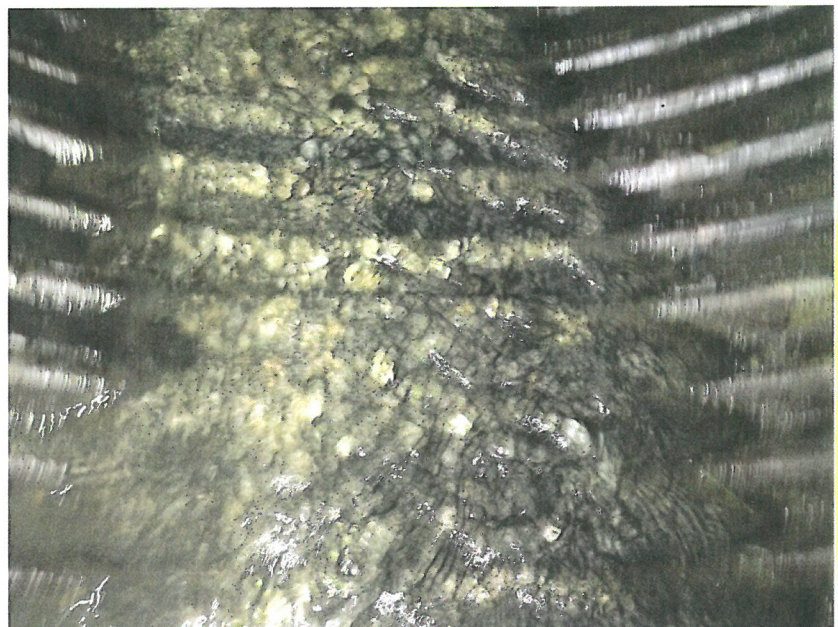
Entry was from the manhole on the intersection of Mt. Vernon and Overbrook Ct. working south to the man hole located on the intersection of 32nd St and Overbrook Ct. (run 1). In this run 95% of the invert is rotted away exposing the gravel bedding. In 30' of this run I was unable to view the invert due to an obstruction and the high water levels resulting from the obstruction. The obstruction is two concrete slabs approximately 8" thick by 4' long by 2.5' wide. They are sitting on top of each other creating a large blockage, which in turn is causing high water levels for some 25' in front of this. All pipe joints were inspected and appeared to be functioning properly, as well as the man hole vaults. No apparent voids or leaks. All damaged areas appear to be contained to the invert.

invert of run1 is gone with gravel
Bedding exposed.

No major issues, deflections, or notable problems were found in either run with exception to the invert deterioration in both runs and the obstruction in run 1. After reviewing the repair at Hever Meats using concrete cloth seems to be a very economical fix verses removal and replace or a paved invert. There is enough pipe remaining to lay the cloth with the run of the pipe and get the required amount of fasteners in place. Please feel free to call me with any questions or discuss your options further.

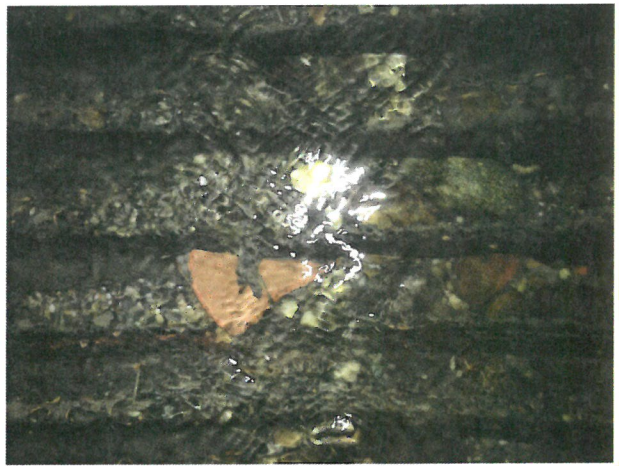
From the manhole on 32nd st. and Overbrook going east down 32nd st. (run 2) there were sections of pipe with the inverts completely rotted away mixed with pipe showing no damage. Pipe joints in this run showed more wear but looked to still be functioning properly with no leaks or gaps.

Bedding exposed on run 2.

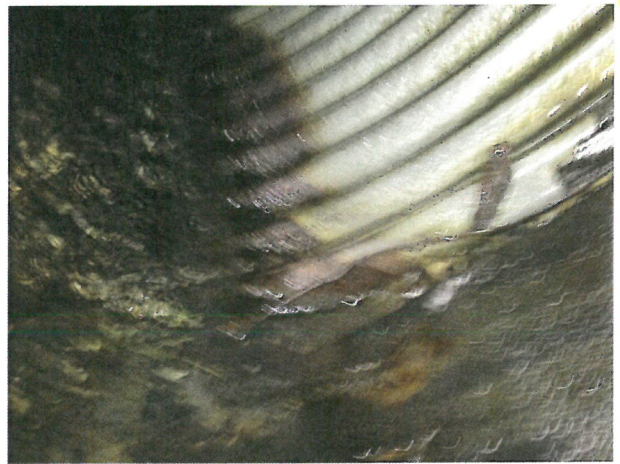
Typical pipe joint throughout both runs

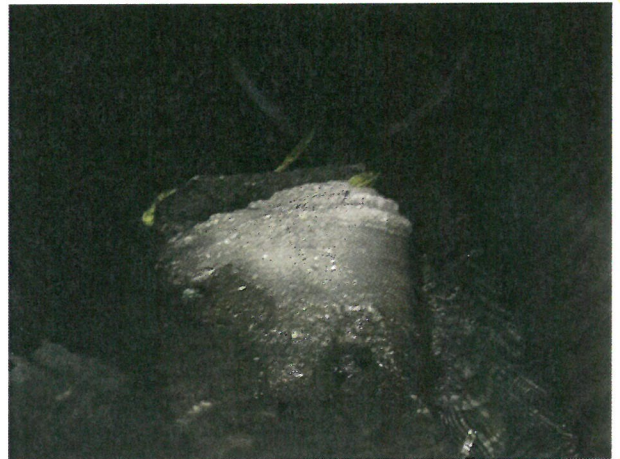
Looking at the obstruction from the north

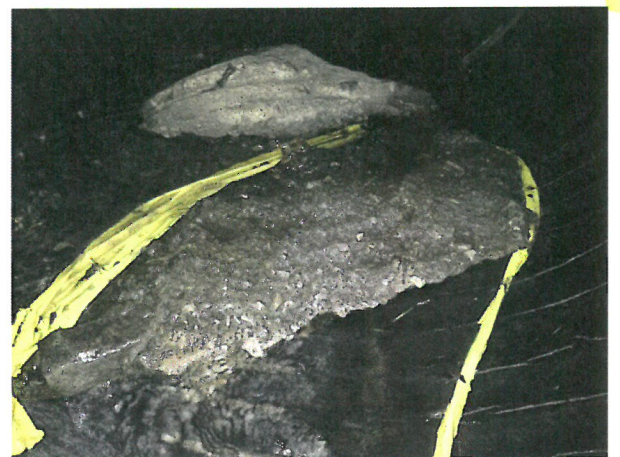
From the south looking north
